DART AEROSPACE LTD	Work Order:	22761
Description: Console Side LH (206 Hi-Slope)	Part Number:	D2602-1
Note: Issue with Part Number D2602-2		
Dwg: D2602 Rev. A1	Qty:	17 20
		Page 1 of 1

DESIGN	DRAWN BY	DART AEROSPACE LTD VICTORIA INTERNATIONAL AIRPORT, CANADA	
CHECKED KE	APPROVED Bm	DRAWING NO. D2602	REV. A
DATE 97.10.22		TITLE CONSOLE SIDE	SHEET 1 OF 1
			SCALE 1:4
A	97.10.22	D2602 WAS D206-547-21/-22	
AI	32.06.04	ADD FINISH

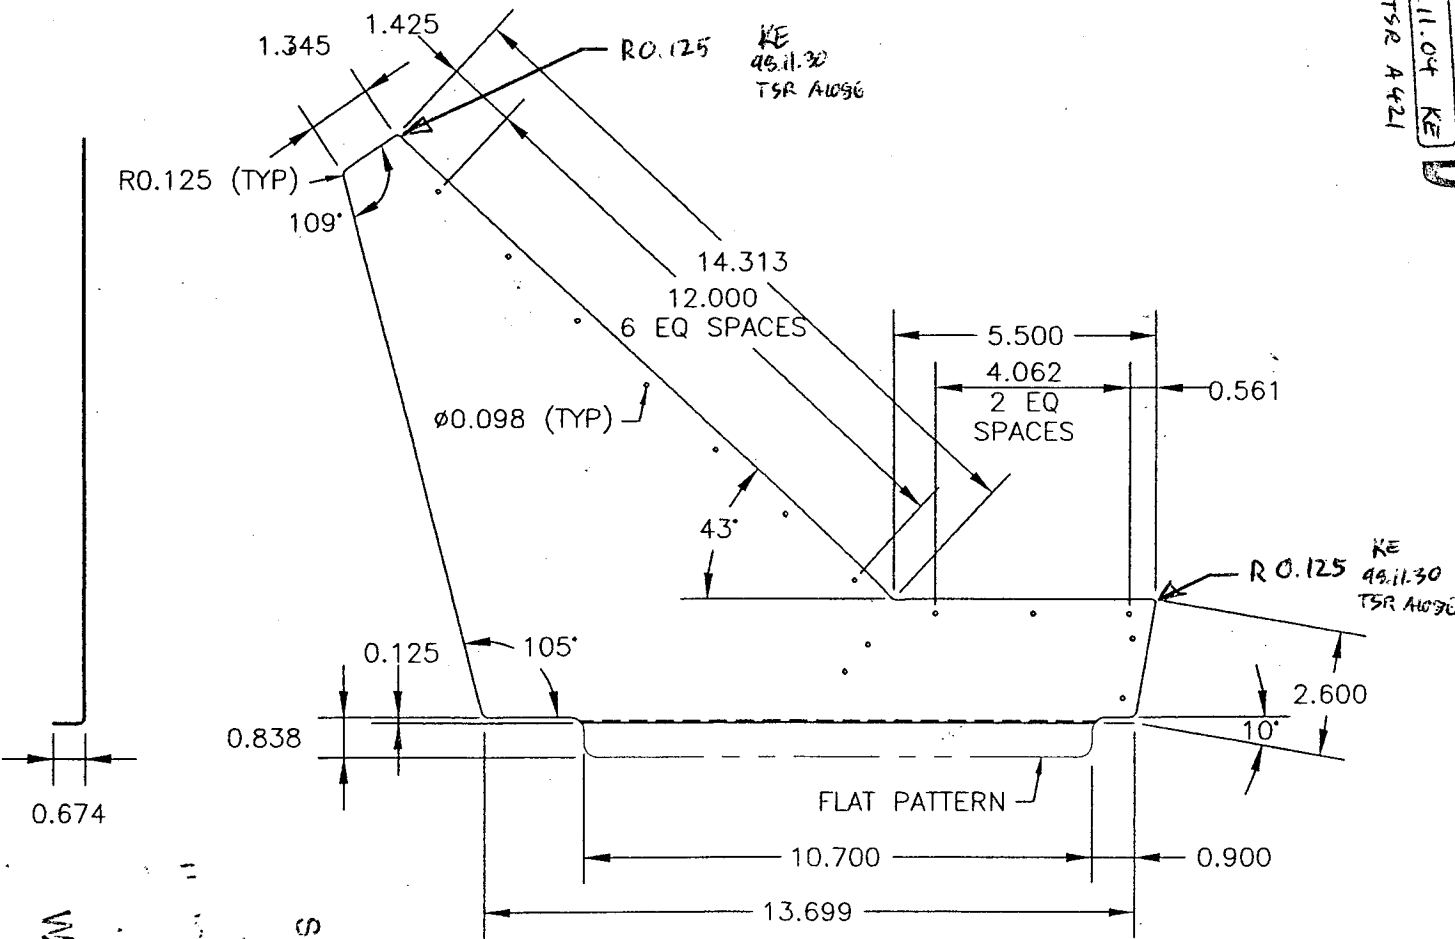
NCR: 22761		WORK ORDER NON-CONFORMANCE (NCR)						
DATE	STEP	Description of NC Section A	Corrective Action Section B			Verification Section C	Approval Design Mgr	Approval QC Inspector
			Initial Design Mgr	Action Description Design Mgr	Sign & Date			
02.06.04	3	0.838" DIMENSION UNDER TOLERANCE ON SOME PARTS BY UP TO 0.030"	CP	WHEN BENDING? PAIR-UP SIMILAR PARTS & MAINTAIN 0.674" FLANGE DIMENSION.	SB 05/01/18 SB	05/01/18	per asst	05/01/18
05/04/12	7	1 part was scrap Bend over tolerance	18 per asst	destroy	SB 05/04/13	05/04/13	per asst	05/04/13
05/04/12

The big question is what happened. Looks like something shifted or lifted up on the HAAS to me.

Having said that, I believe you and I agree that the parts could be salvaged (if this is more cost effective) by bending them in pairs (one left and one right) and preserving the width of the tab as much as possible (reduce console height slightly, but left MUST match right).

If you decide to salvage, you can use this email as my acceptance of the deviation and attach to WO.
